FINAL REPORT
SEPTEMBER 1995

REPORT NO. 95-08

PLASTIC PALLET PRODUCED
BY ALKET INDUSTRIES
MIL-STD-1660 TESTS

Prepared for:
U.S. Army Armament Research, Development
and Engineering Center
ATTN: AMSTA-AR-ESK
Rock Island, IL 61299-7300

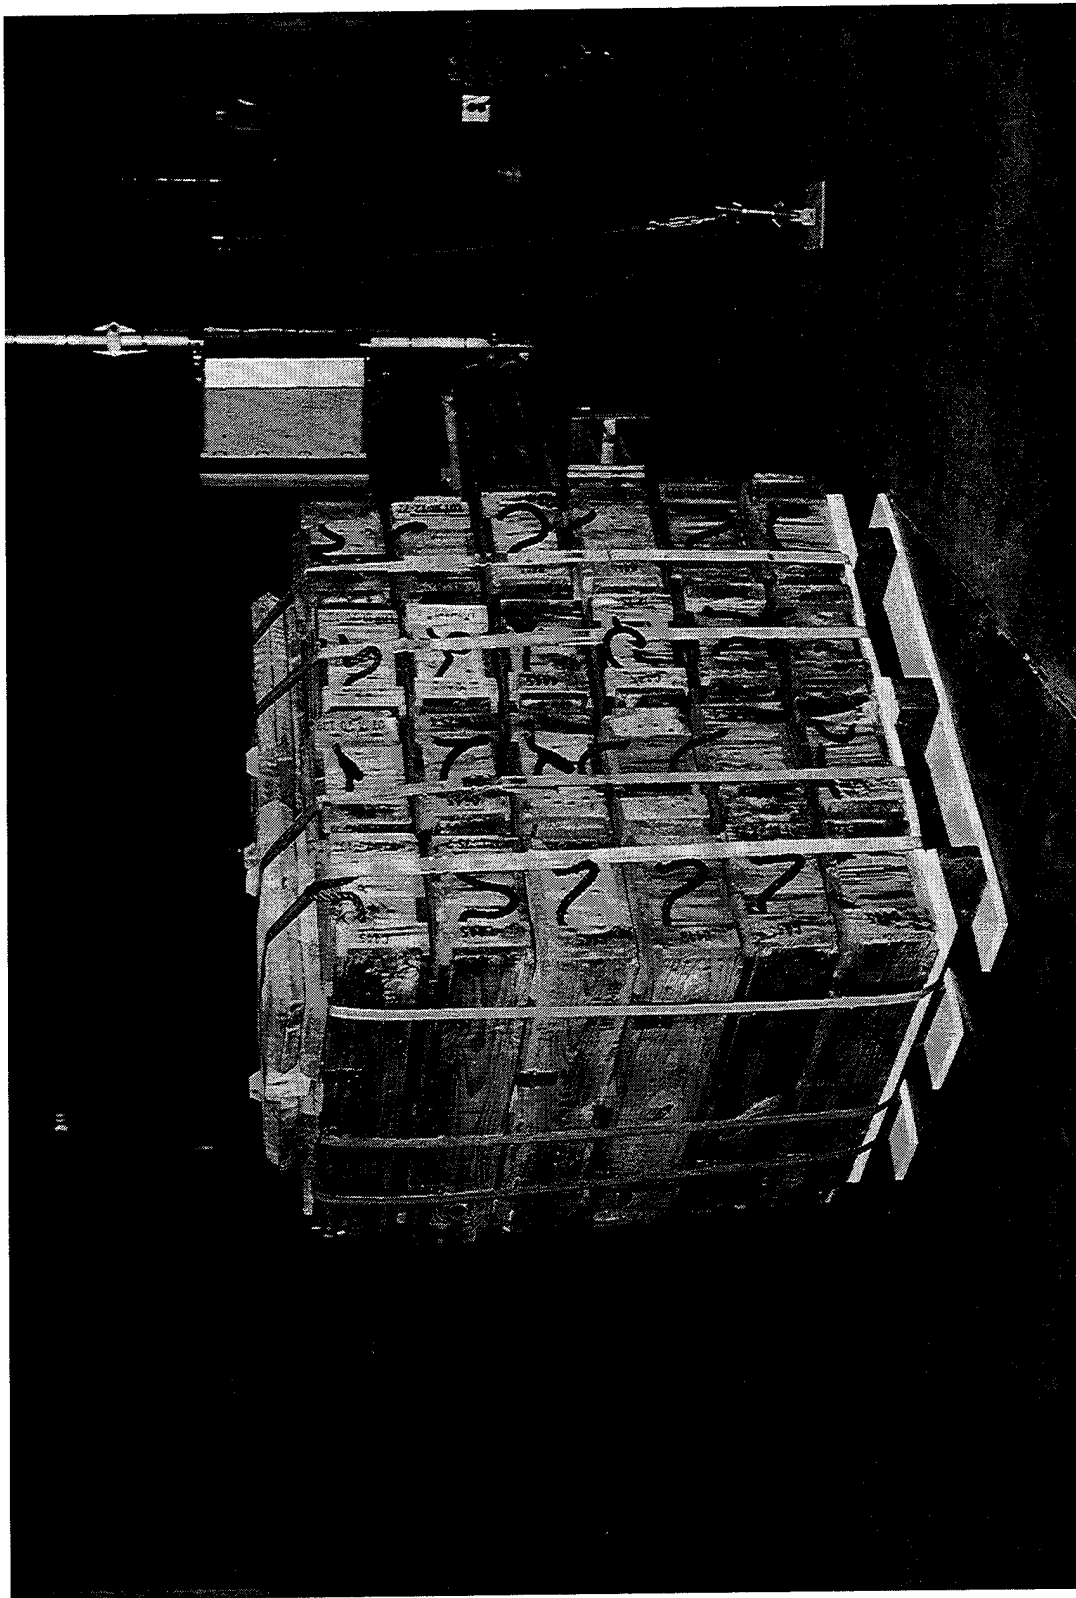
U.S. ARMY DEFENSE AMMUNITION CENTER AND SCHOOL - SAVANNA, IL	
AO317-SCN95-106-1335. This photo shows the test load on pallet no. 1. The weights are banded to the top of the load to create a 4,000-pound load.

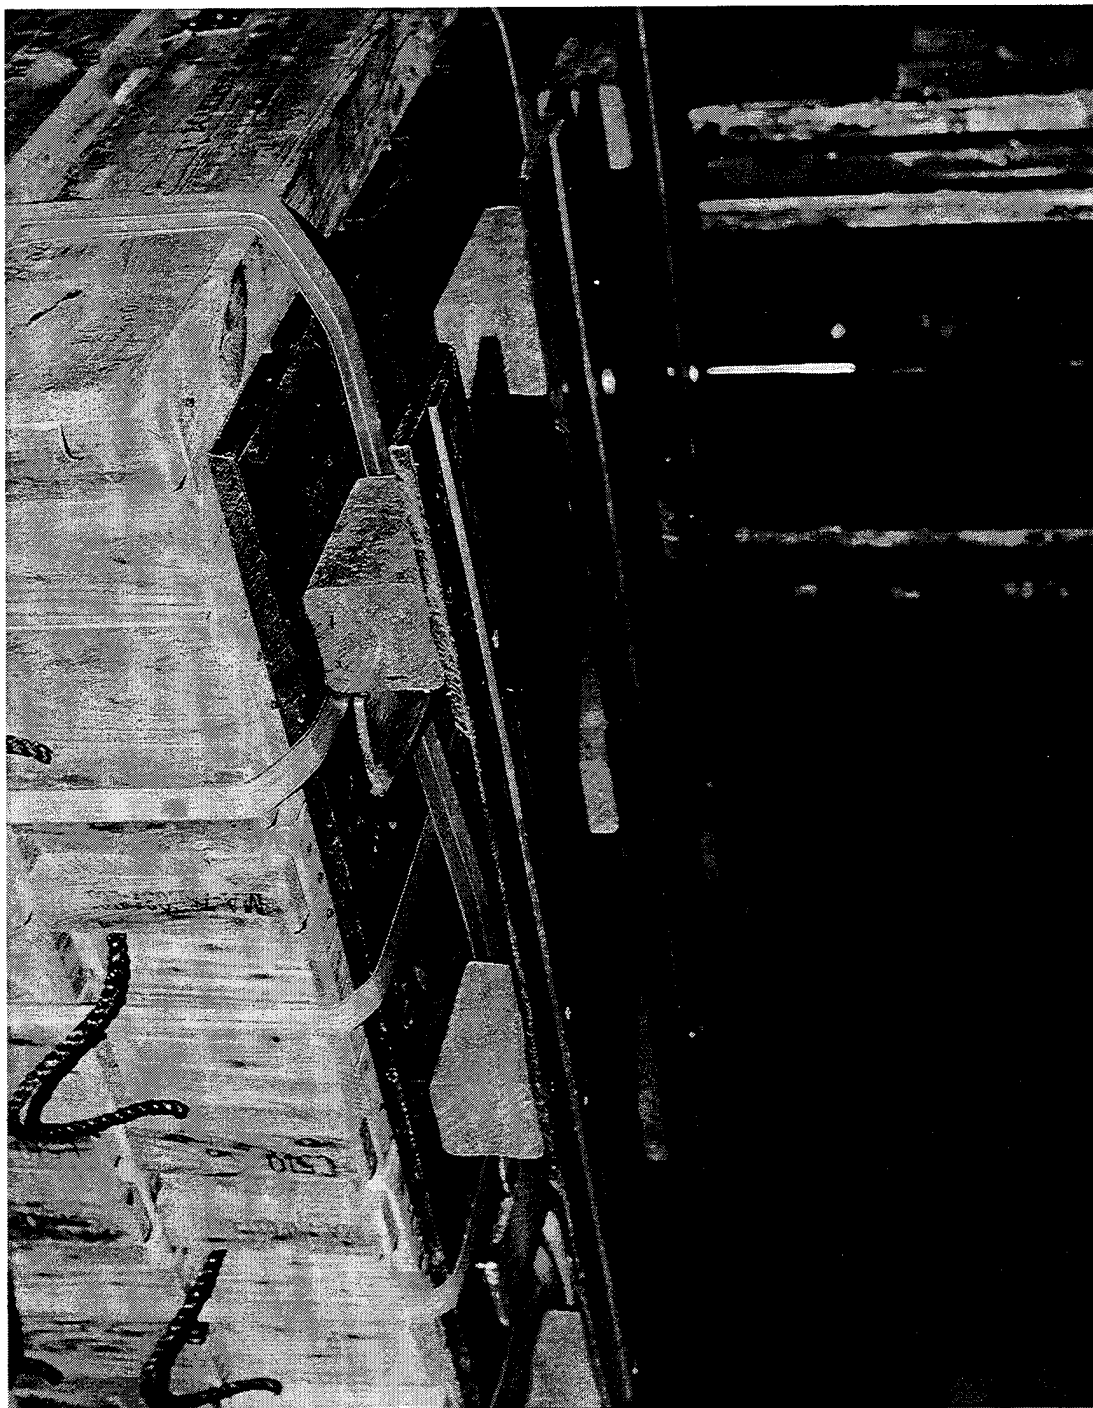
U.S. ARMY DEFENSE AMMUNITION CENTER AND SCHOOL - SAVANNA, IL	
AO317-SCN95-106-1342. This photo shows pallet no. 2 prior to testing.

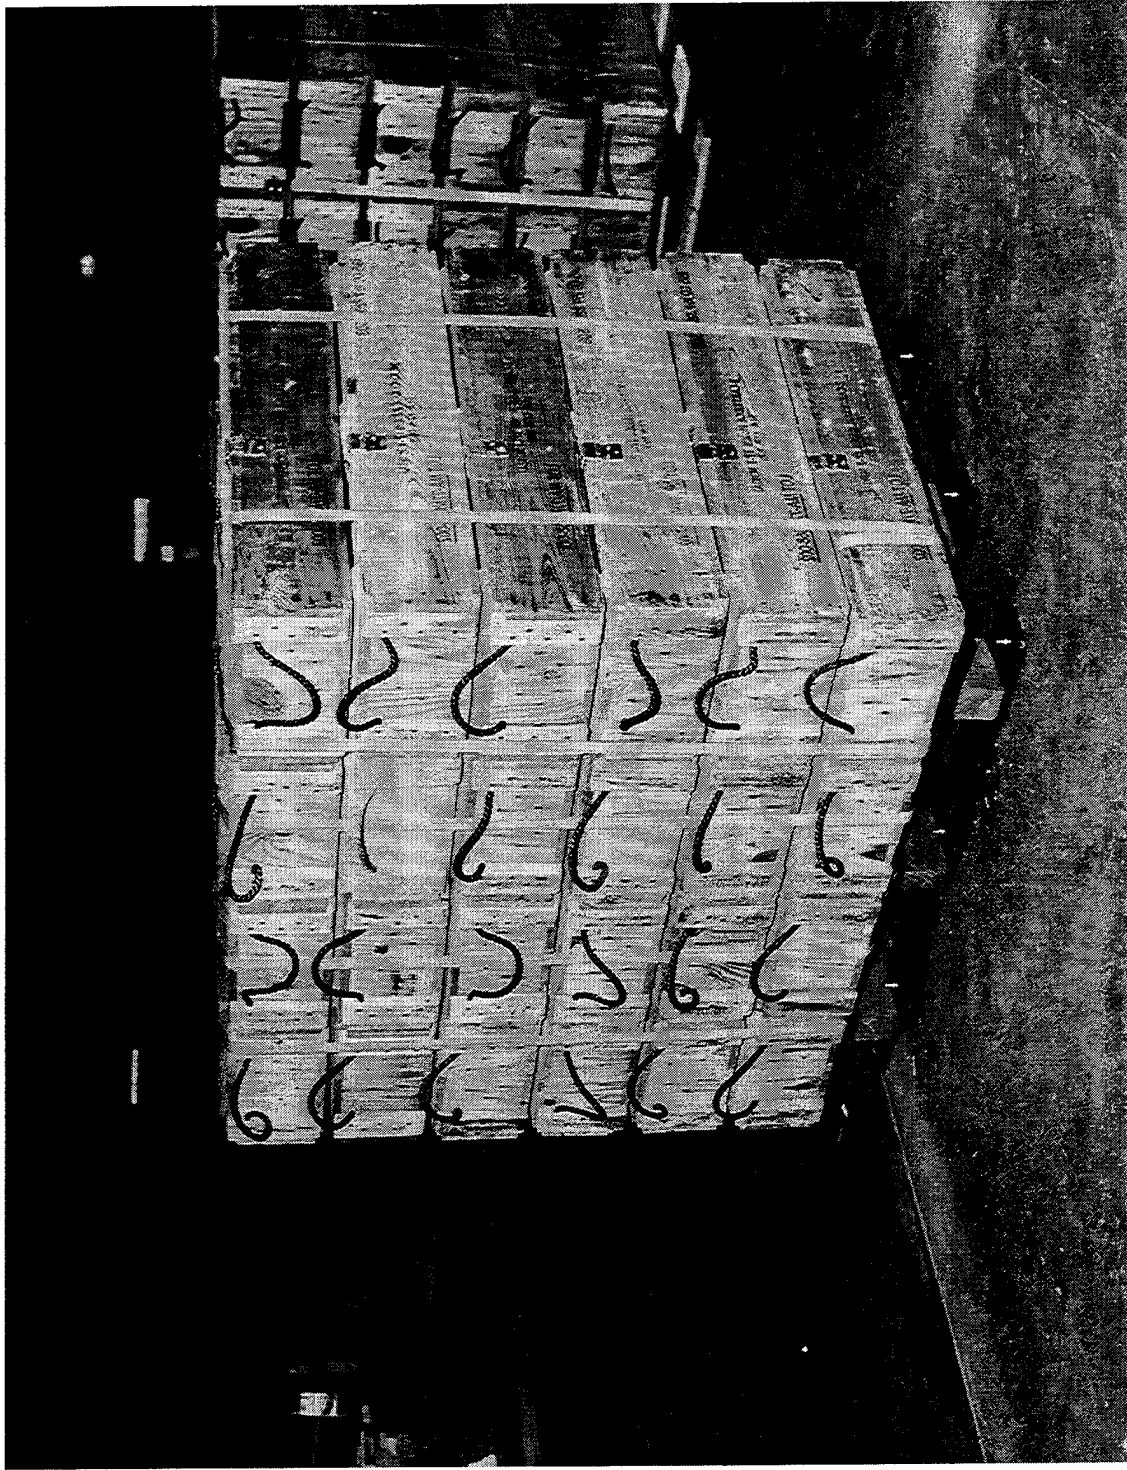
U.S. ARMY DEFENSE AMMUNITION CENTER AND SCHOOL - SAVANNA, IL	
AO317-SCN95-123-1302. This photo shows the load on pallet no. 2. Two of the boxes contain lead weights to achieve a 4,000-pound load.

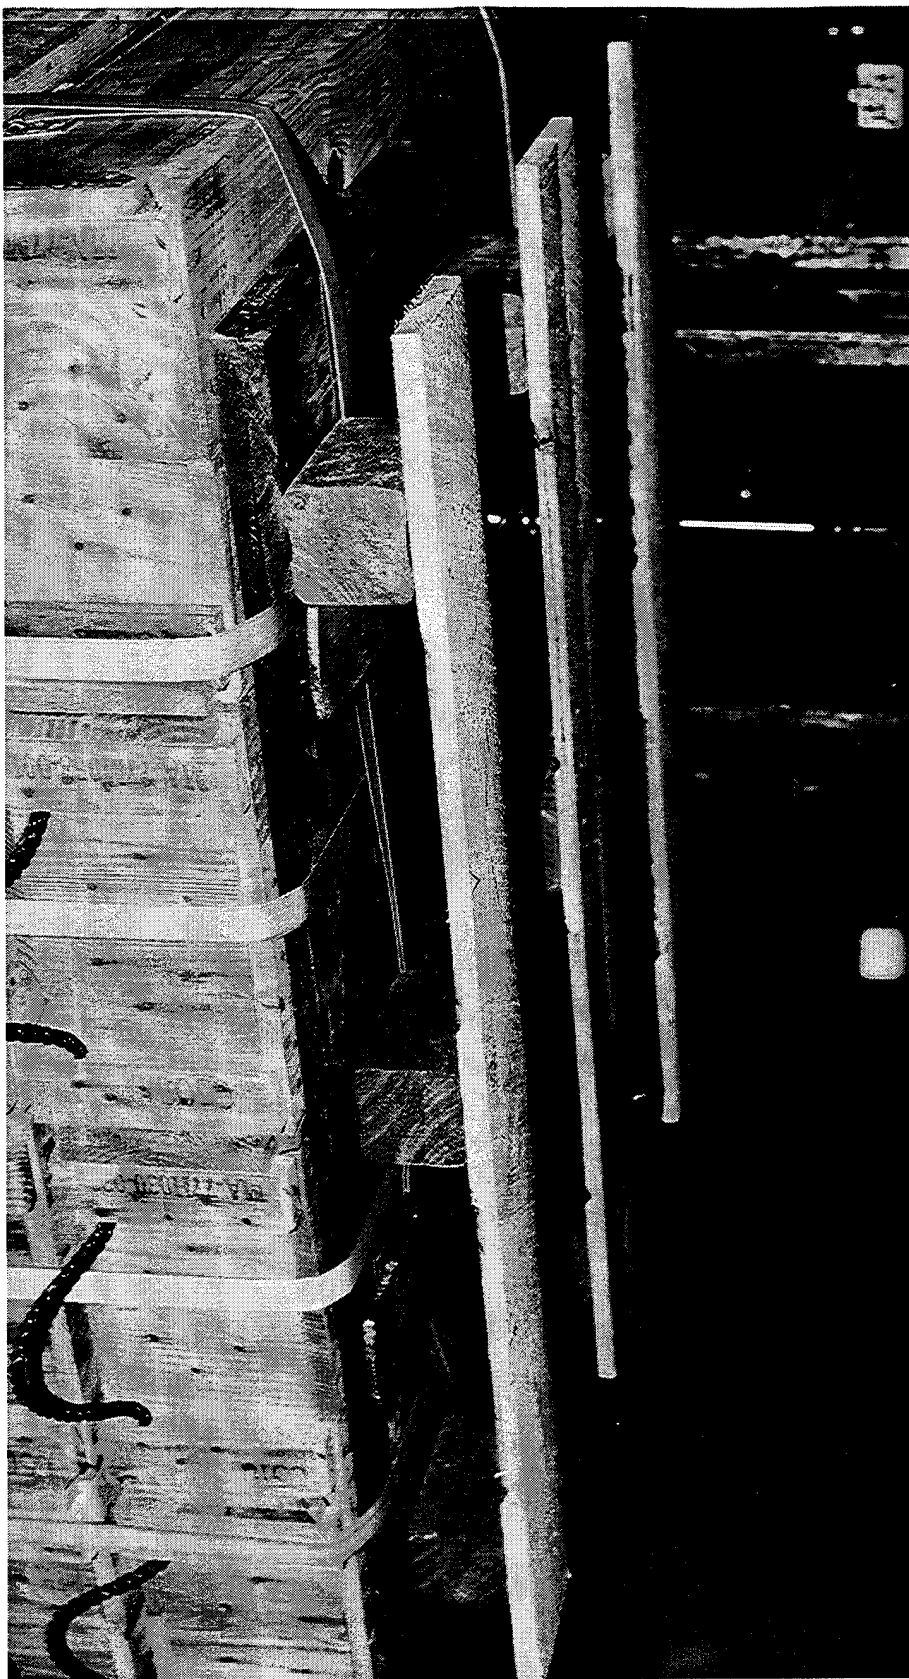
U.S. ARMY DEFENSE AMMUNITION CENTER AND SCHOOL - SAVANNA, IL	
AO317-SCN95-126-1344. This photo shows pallet no. 3 prior to testing. Note the oak skids used in place of the plastic skids with steel strip attached.

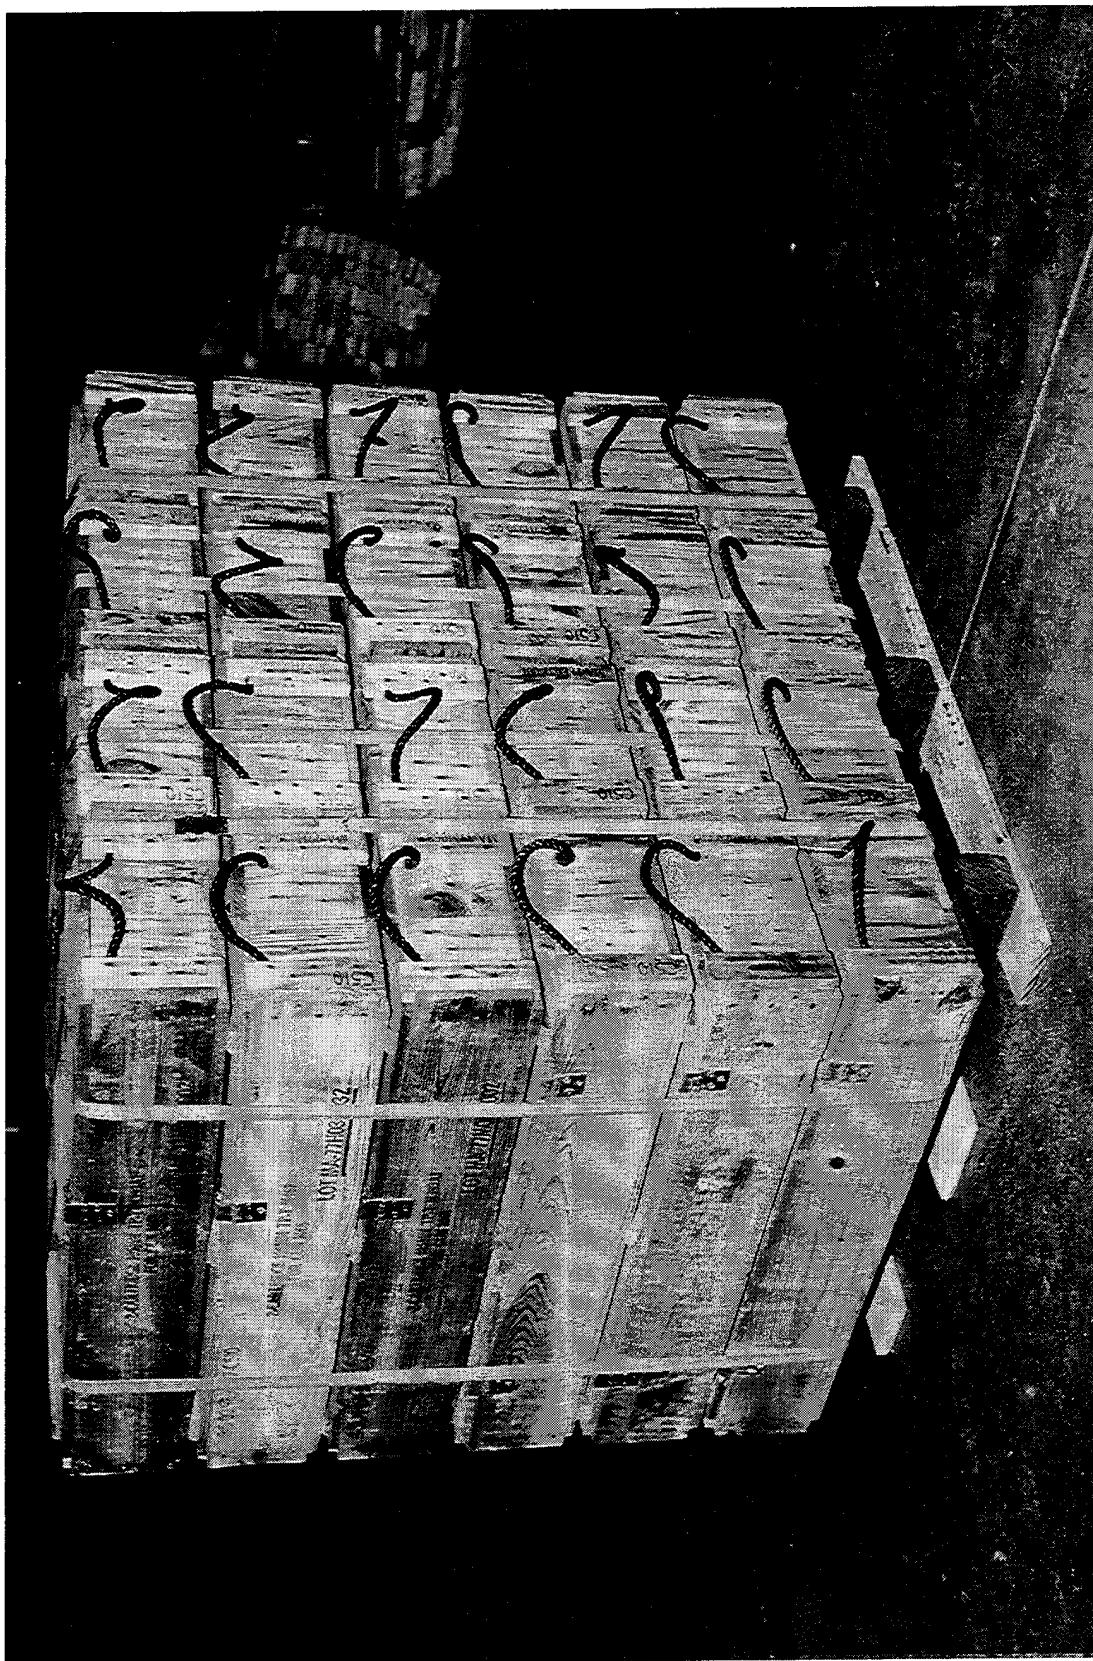
U.S. ARMY DEFENSE AMMUNITION CENTER AND SCHOOL - SAVANNA, IL	
AO317-SCN95-126-1340. This photo shows the load on pallet no. 3. Two boxes contain weights to achieve a 4,000-pound load.

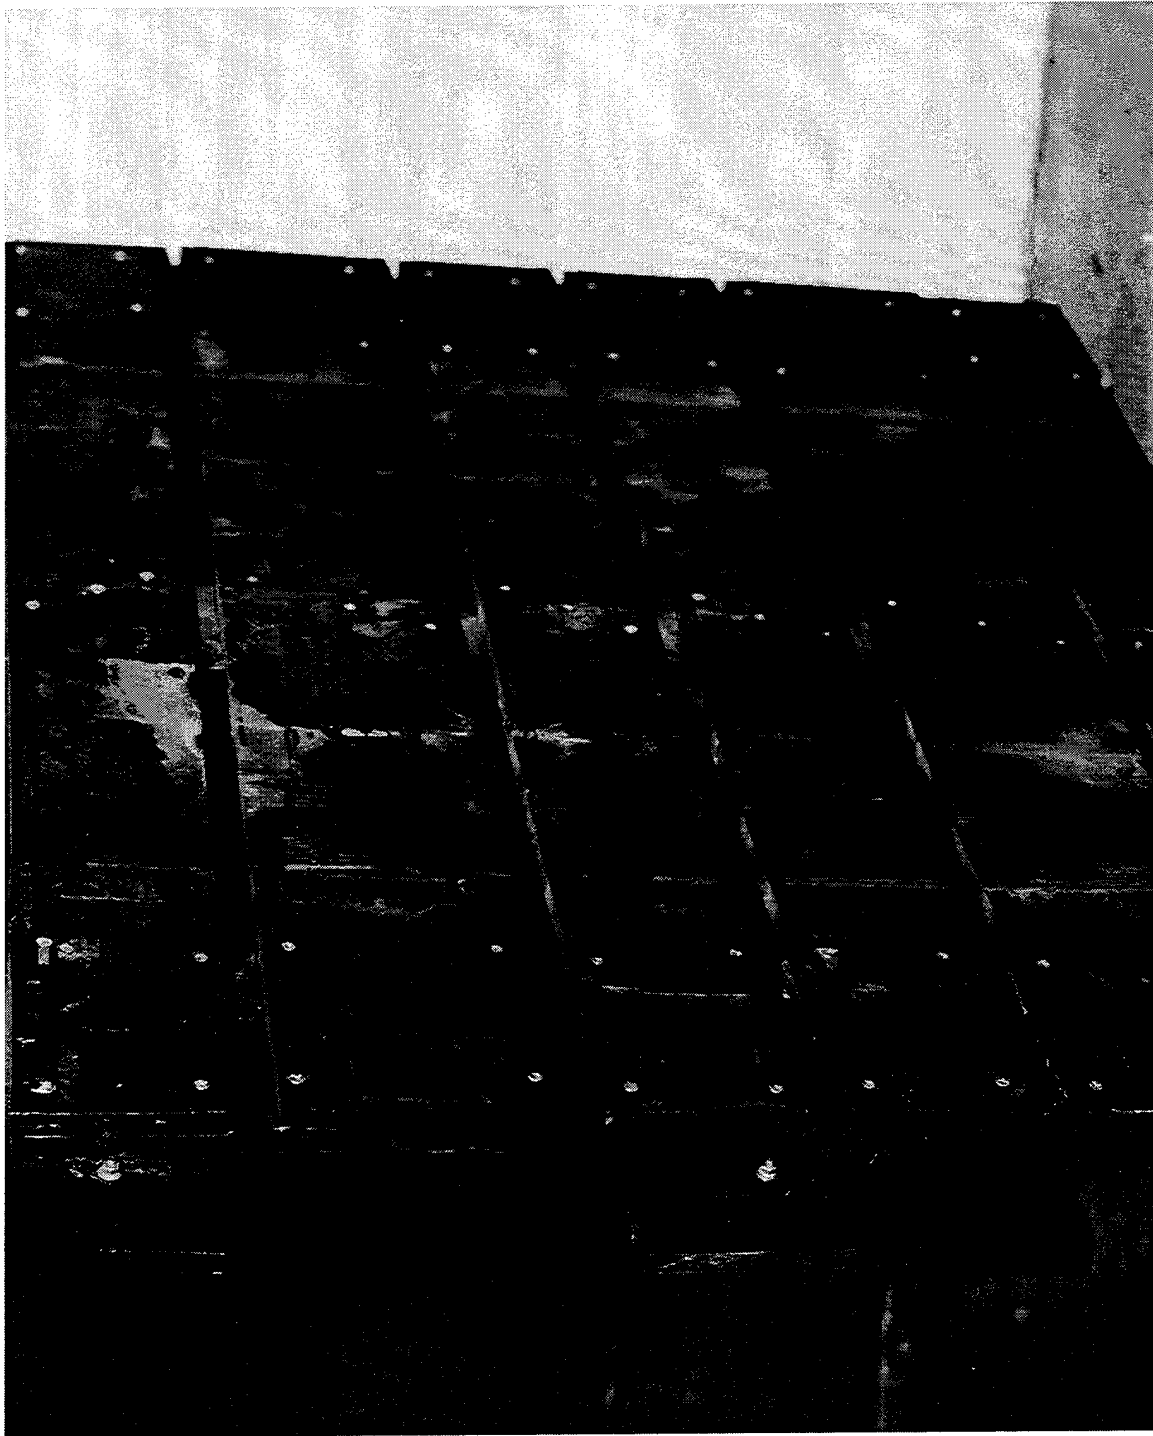
F. END OF TEST INSPECTION. After the load was removed from the pallet, the pallet was inspected. No damage was evident. The pallet passed MIL-STD-1660 criteria with cold soak.

U.S. ARMY DEFENSE AMMUNITION CENTER AND SCHOOL - SAVANNA, IL	
AO317-SCN95-2571. This photo shows the repaired pallet no. 4 following MIL-STD-1660 cold soak testing. No significant damage occurred.

A. GENERAL. The deck board that was broken in the previous set of tests was removed and a deck board from test sample no. 2 was used to replace the broken deck board.
